## Onsite Excavator

**RP049156**

Notes AHS161 - 3750HR MINOR SERVICE  
Site contact - Mitch 0498 200 188 - BOOKED FOR 7/5 AM

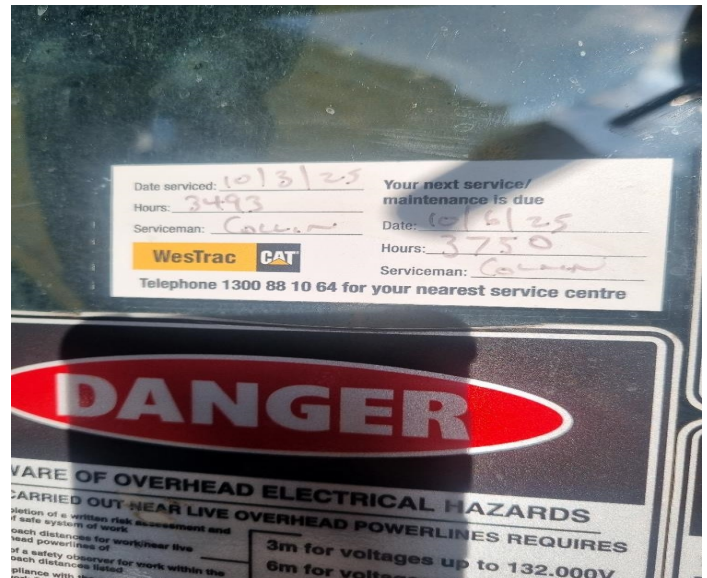
Take a Photo of the Problem

250hr service

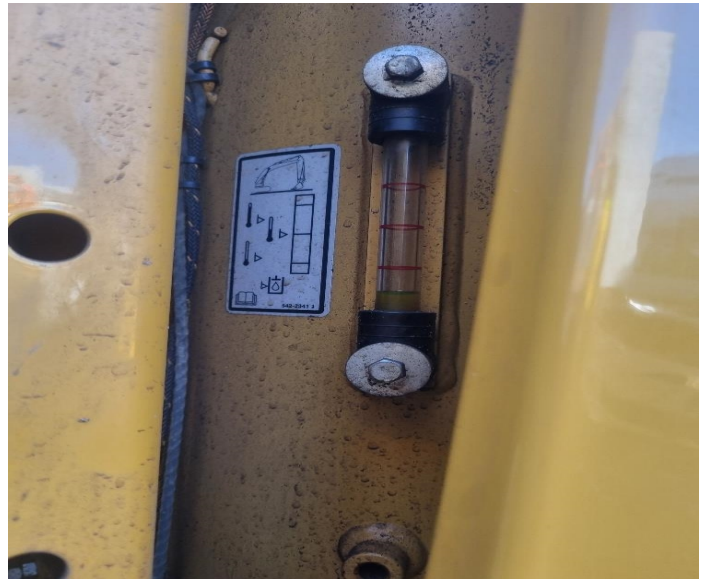
Take a Photo of Hydraulic Level

YES
