MACHINE SERVICE REPORT

RO Number: E33588 | Service Date: January 9, 2026 12:25 pm

Customer:	Australian hammer	Hour Meter:	2070
Model:	Sk225-7	Service Type:	2000
Serial Number:	YB09015287	Service Interval:	2000 Hour Service

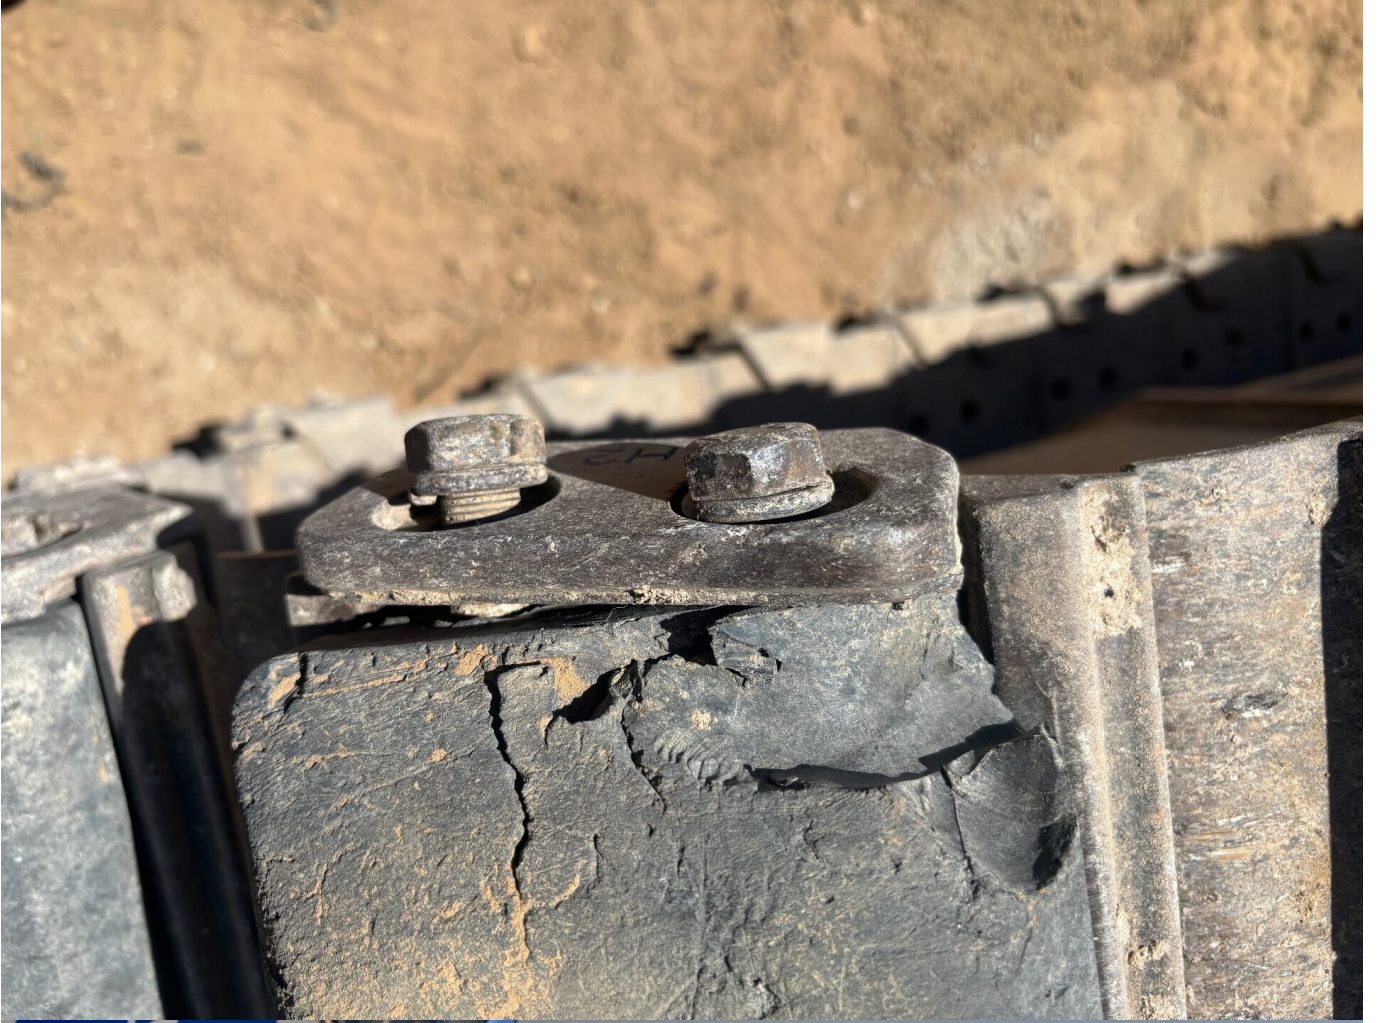
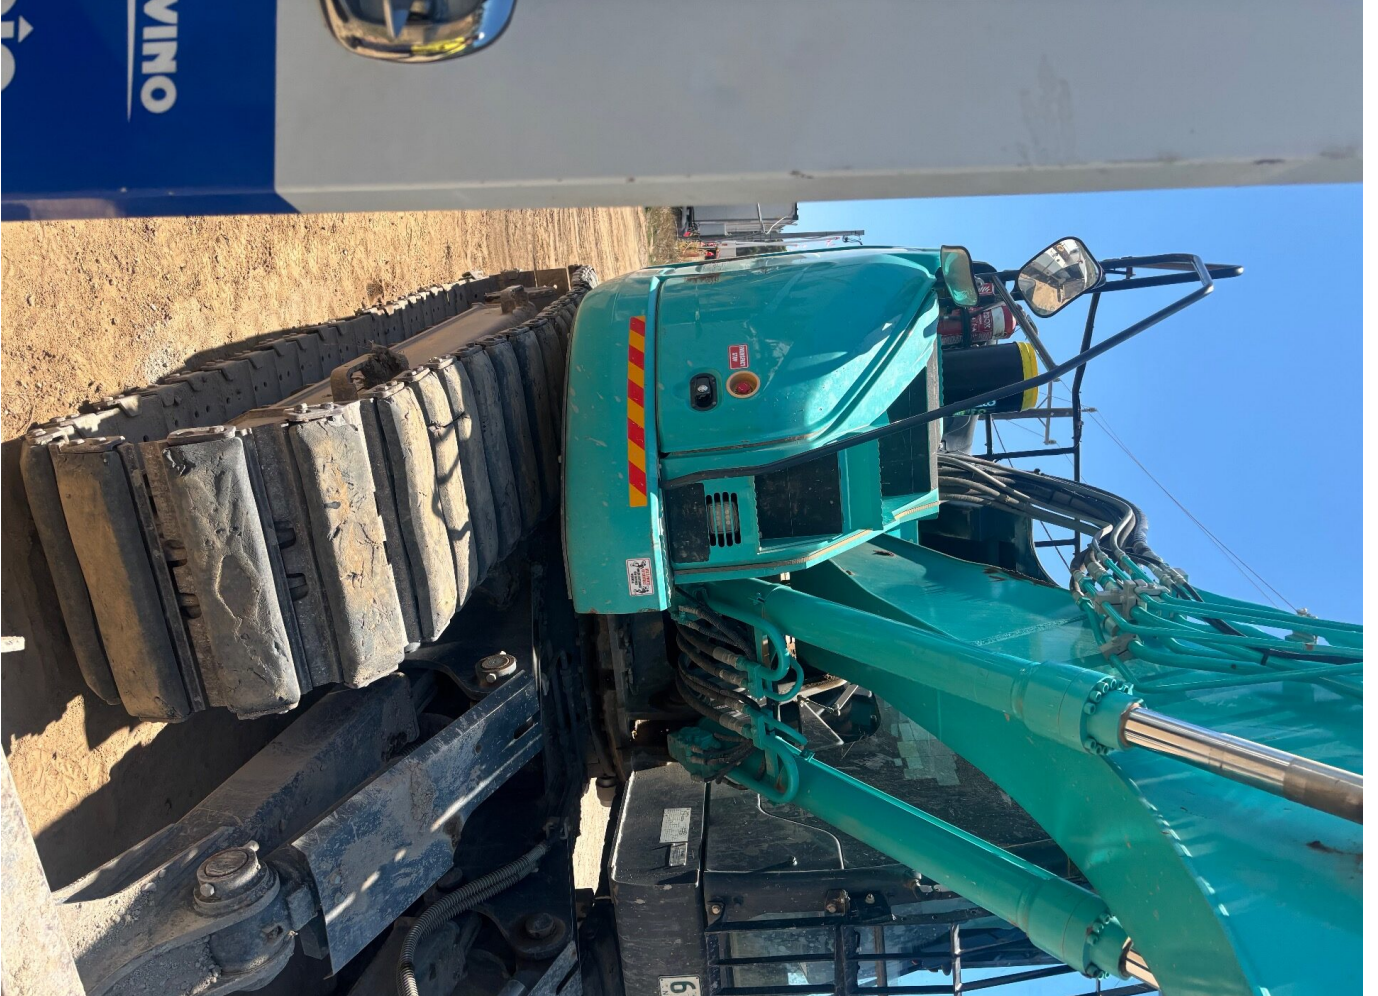
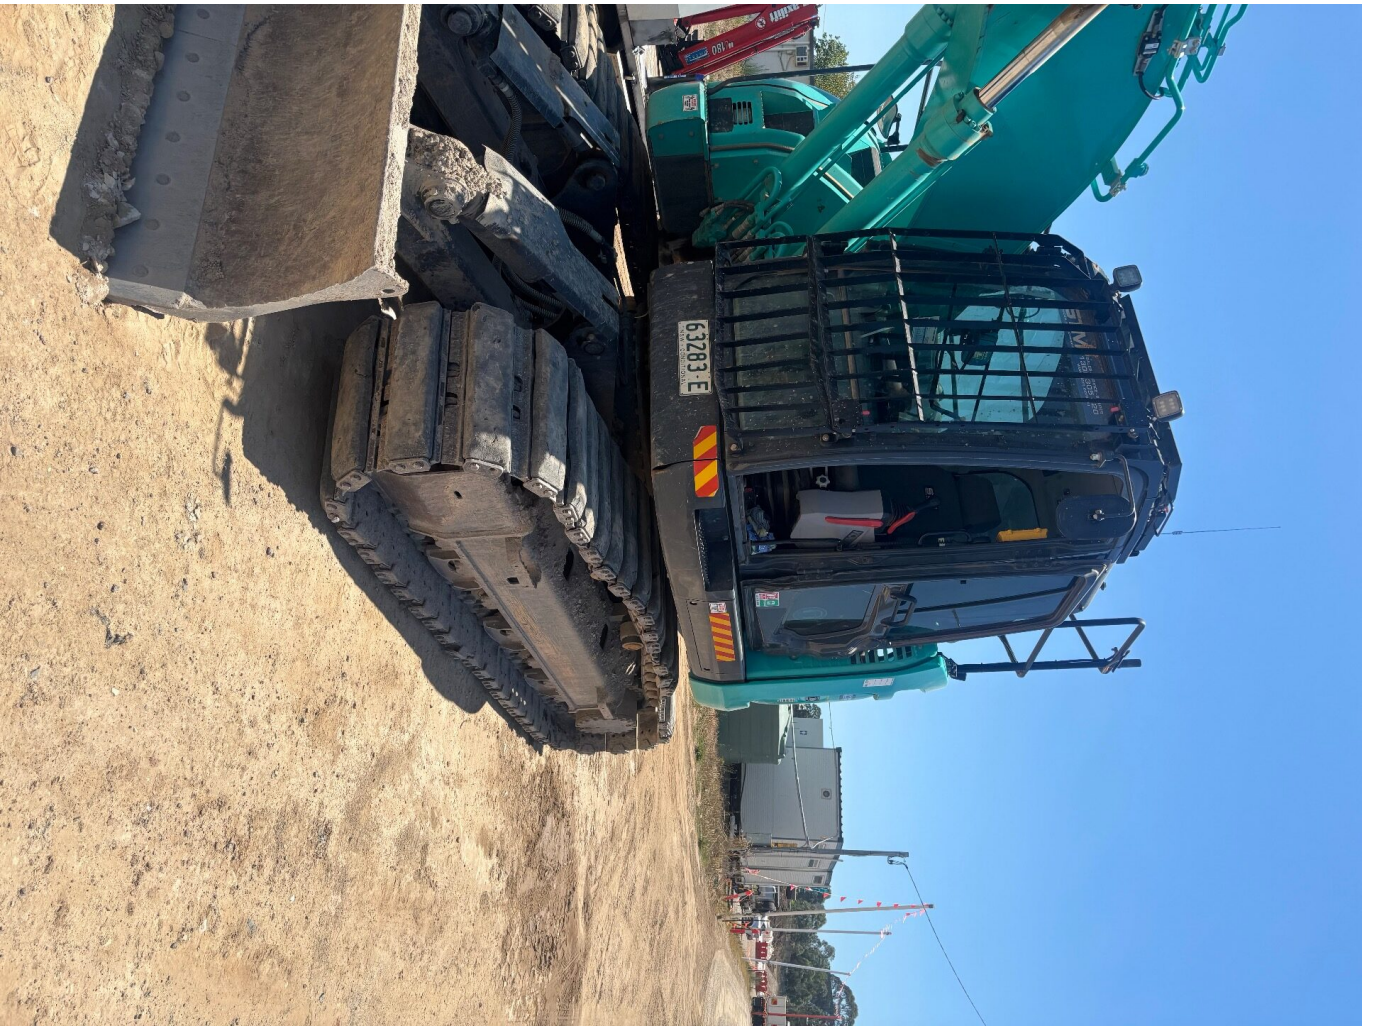
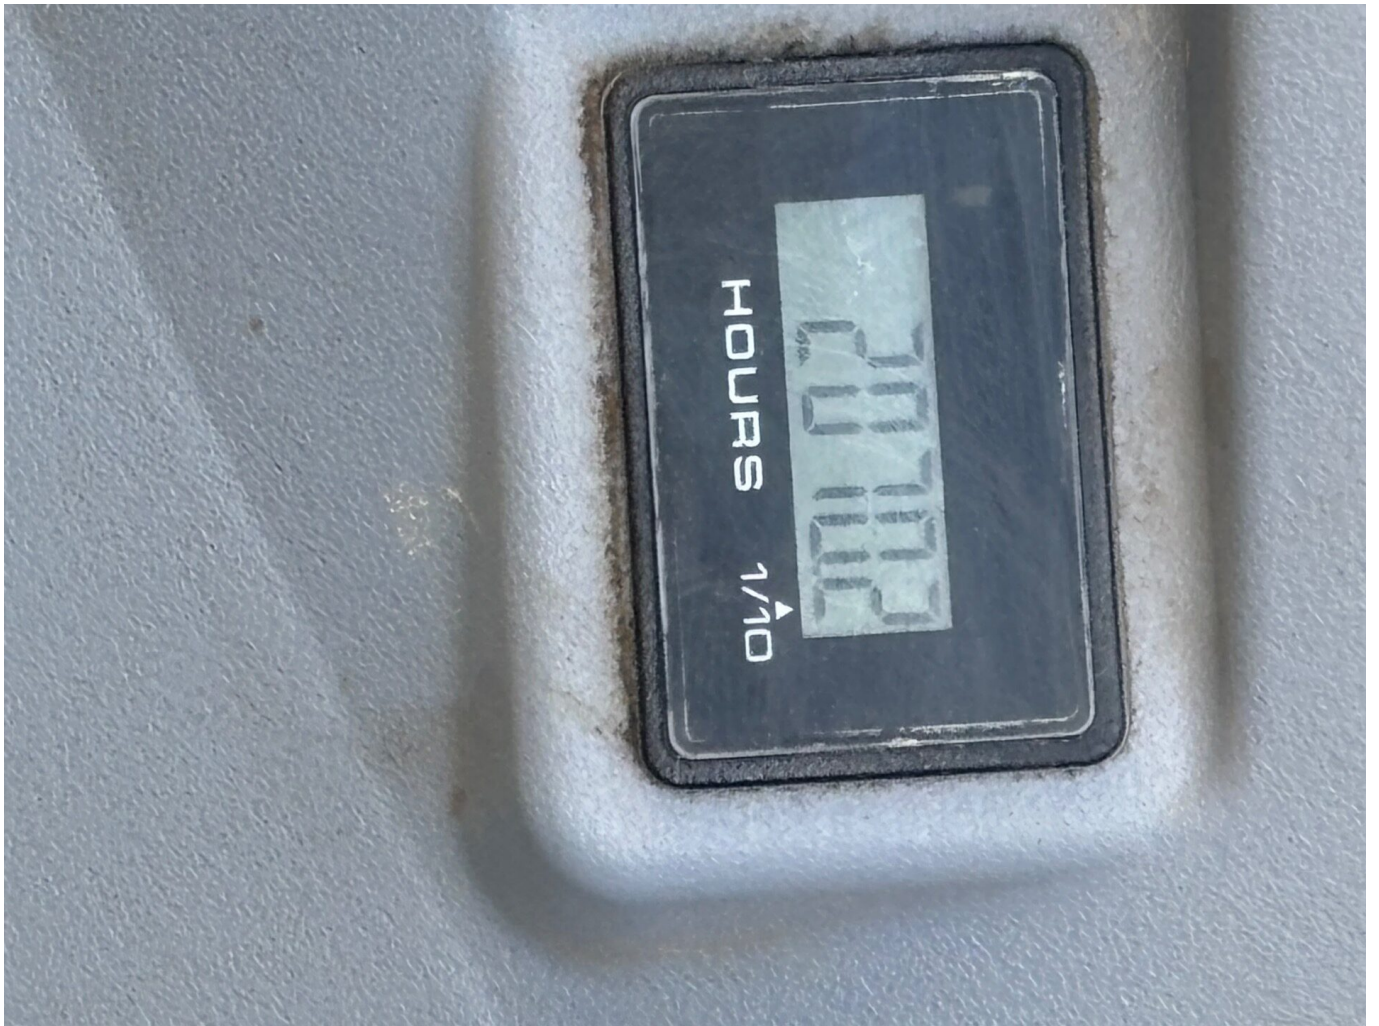
Before Service Photos

The clip on road pads are all loose and because of that the bolts are all bent or snapped I recommend replacing there are also a few pads missing
