MACHINE SERVICE REPORT

RO Number: E33965 | Service Date: February 27, 2026 11:10 am

Customer:	Australian hammer supplies hire	Hour Meter:	1222
Model:	Sk135sr-7	Service Type:	1000
Serial Number:	Yy09053184	Service Interval:	1000 Hour Service

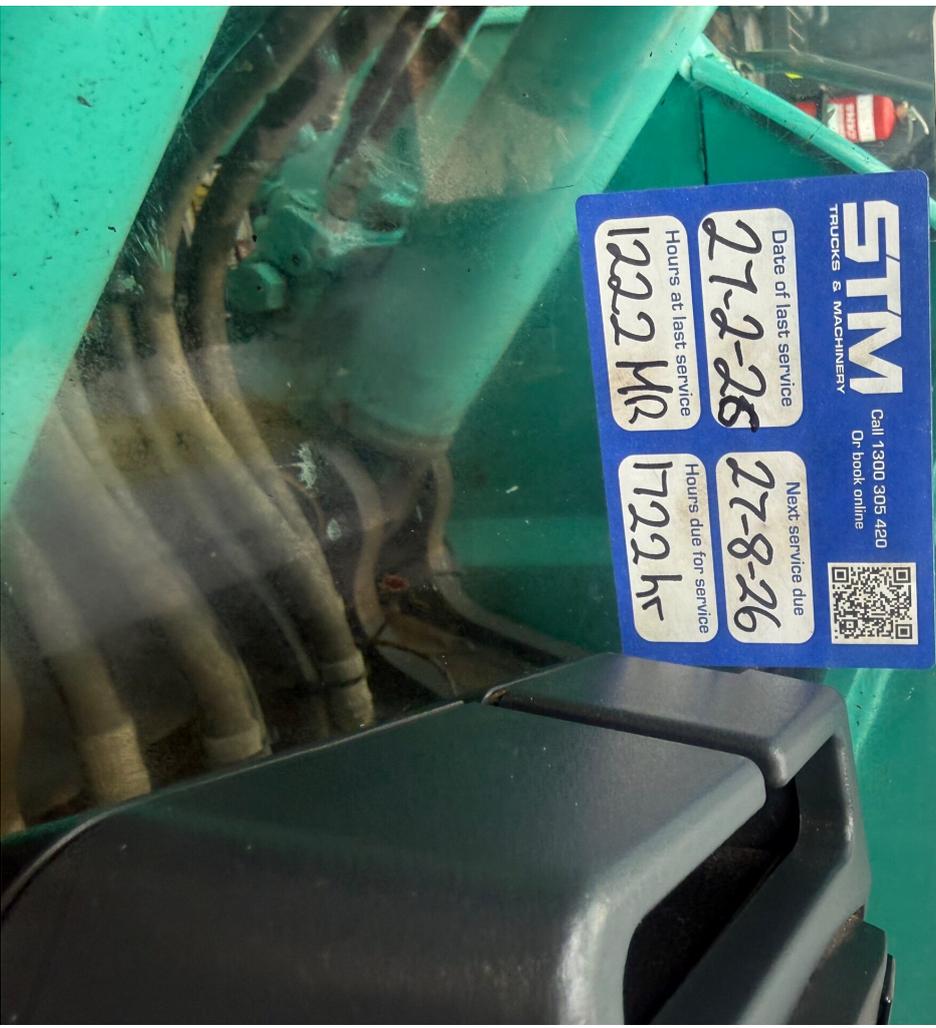
Date of last service
27-2-28

Hours at last service
1222 hr

Next service due
27-8-26

Hours due for service
1722 hr
