## MACHINE SERVICE REPORT

RO Number: E34273 | Service Date: April 15, 2026 11:23 am

<b>Customer:</b>	Aussie Hammer	<b>Hour Meter:</b>	1681
<b>Model:</b>	135-7	<b>Service Type:</b>	500
<b>Serial Number:</b>	Yy09053184	<b>Service Interval:</b>	500 Hour Service

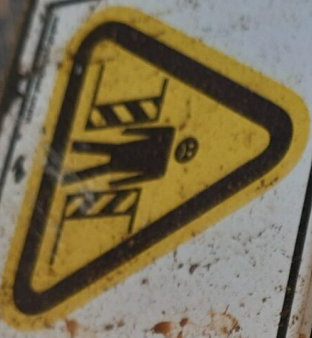
Model : SK135SR-7

Serial Number : YY09053184

YN20102489P1
