MACHINE SERVICE REPORT

RO Number: E35460 | Service Date: September 9, 2026 2:38 pm

Customer:	AHSH	**Hour Meter:**	2466
Model:	Sk135sr-7	**Service Type:**	500
Serial Number:	4783	**Service Interval:**	500 Hour Service

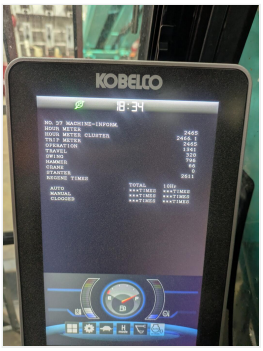
Hour Meter

Hour meter damaged
