## PM 1 PERFORM (250 HOURS INTERVAL)

### PM Checklist

| Model | 325F | Completed On | 30/04/2025 6:22:50 PM |
| Equipment Family | Medium Hydraulic Excavator | Inspector | Francesco Stefanetto |

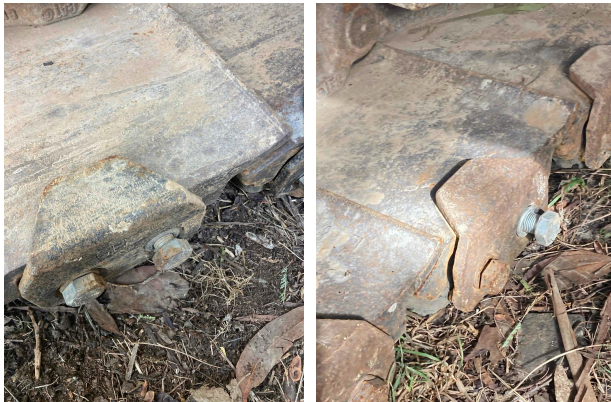
Comments: 250 hours service and inspection performed  
DEF pump filter needs replacing  
Right track assembly pads missing and som mounting bolts loose

**Image Comment(s):**Loose mounting bolts

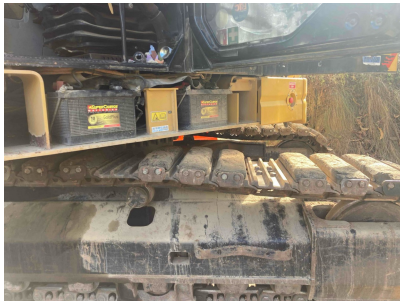
**Image Comment(s):**2x missing track pads right side assembly

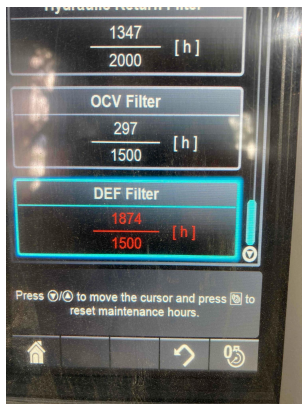
**1.7 PERFORM PM 1** *ACTION*

Comments: DEF filter over hours for replacement.

**Image Comment(s):**Def filter hours over
