# MACHINE SERVICE REPORT

RO Number: E34714 | Service Date: June 18, 2026 9:43 am

| Model: | Sk135sr-7 | Service Type: | 500 |
| Serial Number: | Yy09054228 | Service Interval: | 500 Hour Service |

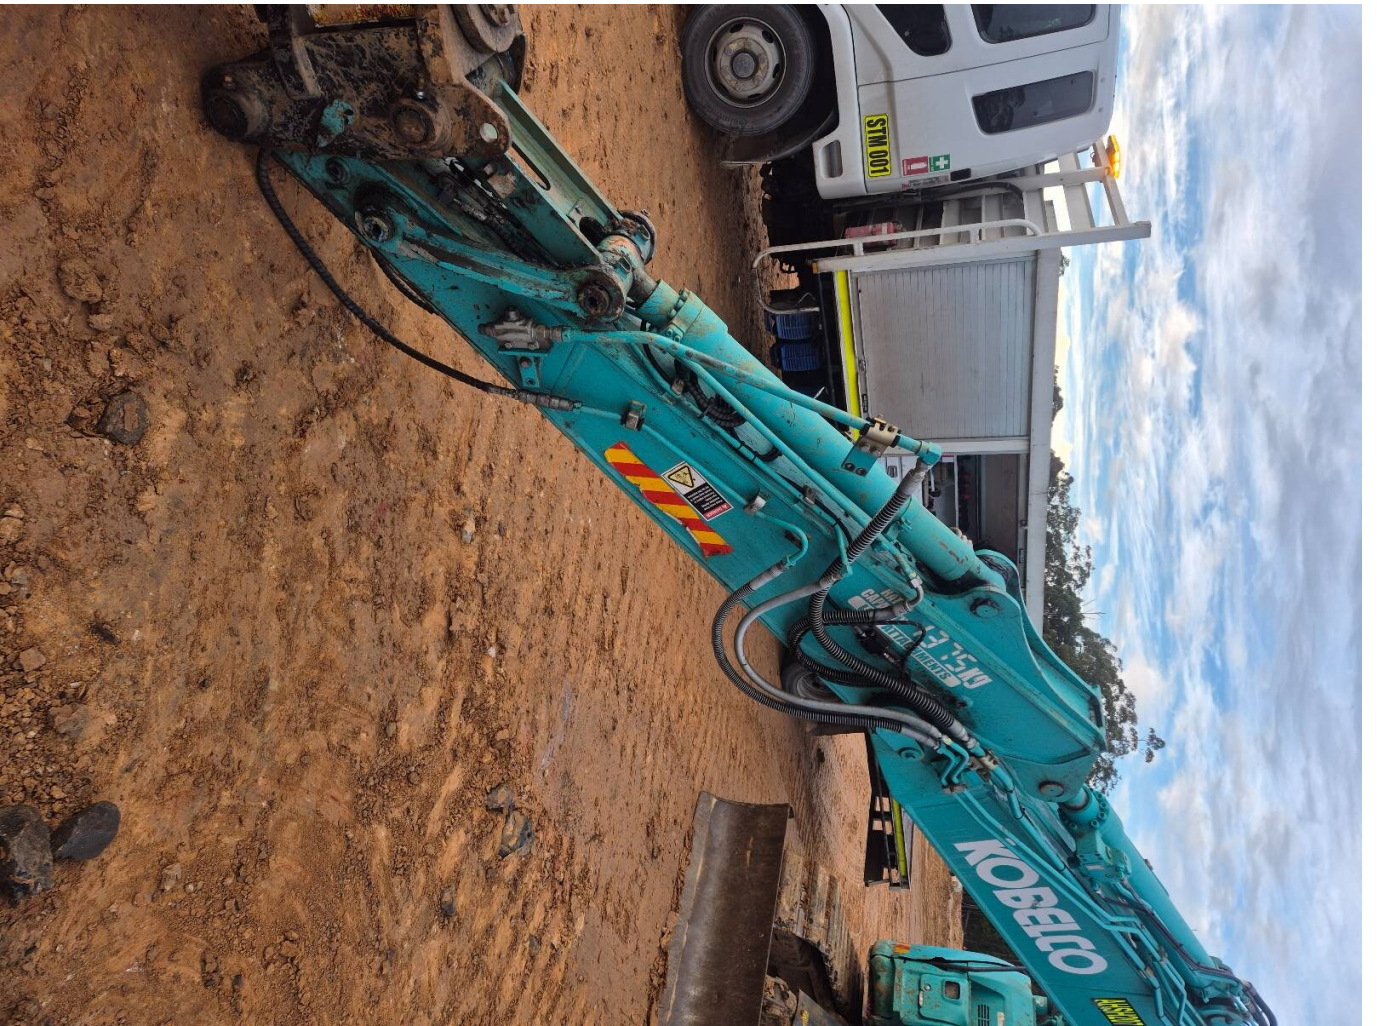
thread snapped

Hyd Breather housing thread damaged  
Missing 3 bolts on hammer hard line on boom replaced  
Missing grease nipple in h link replaced

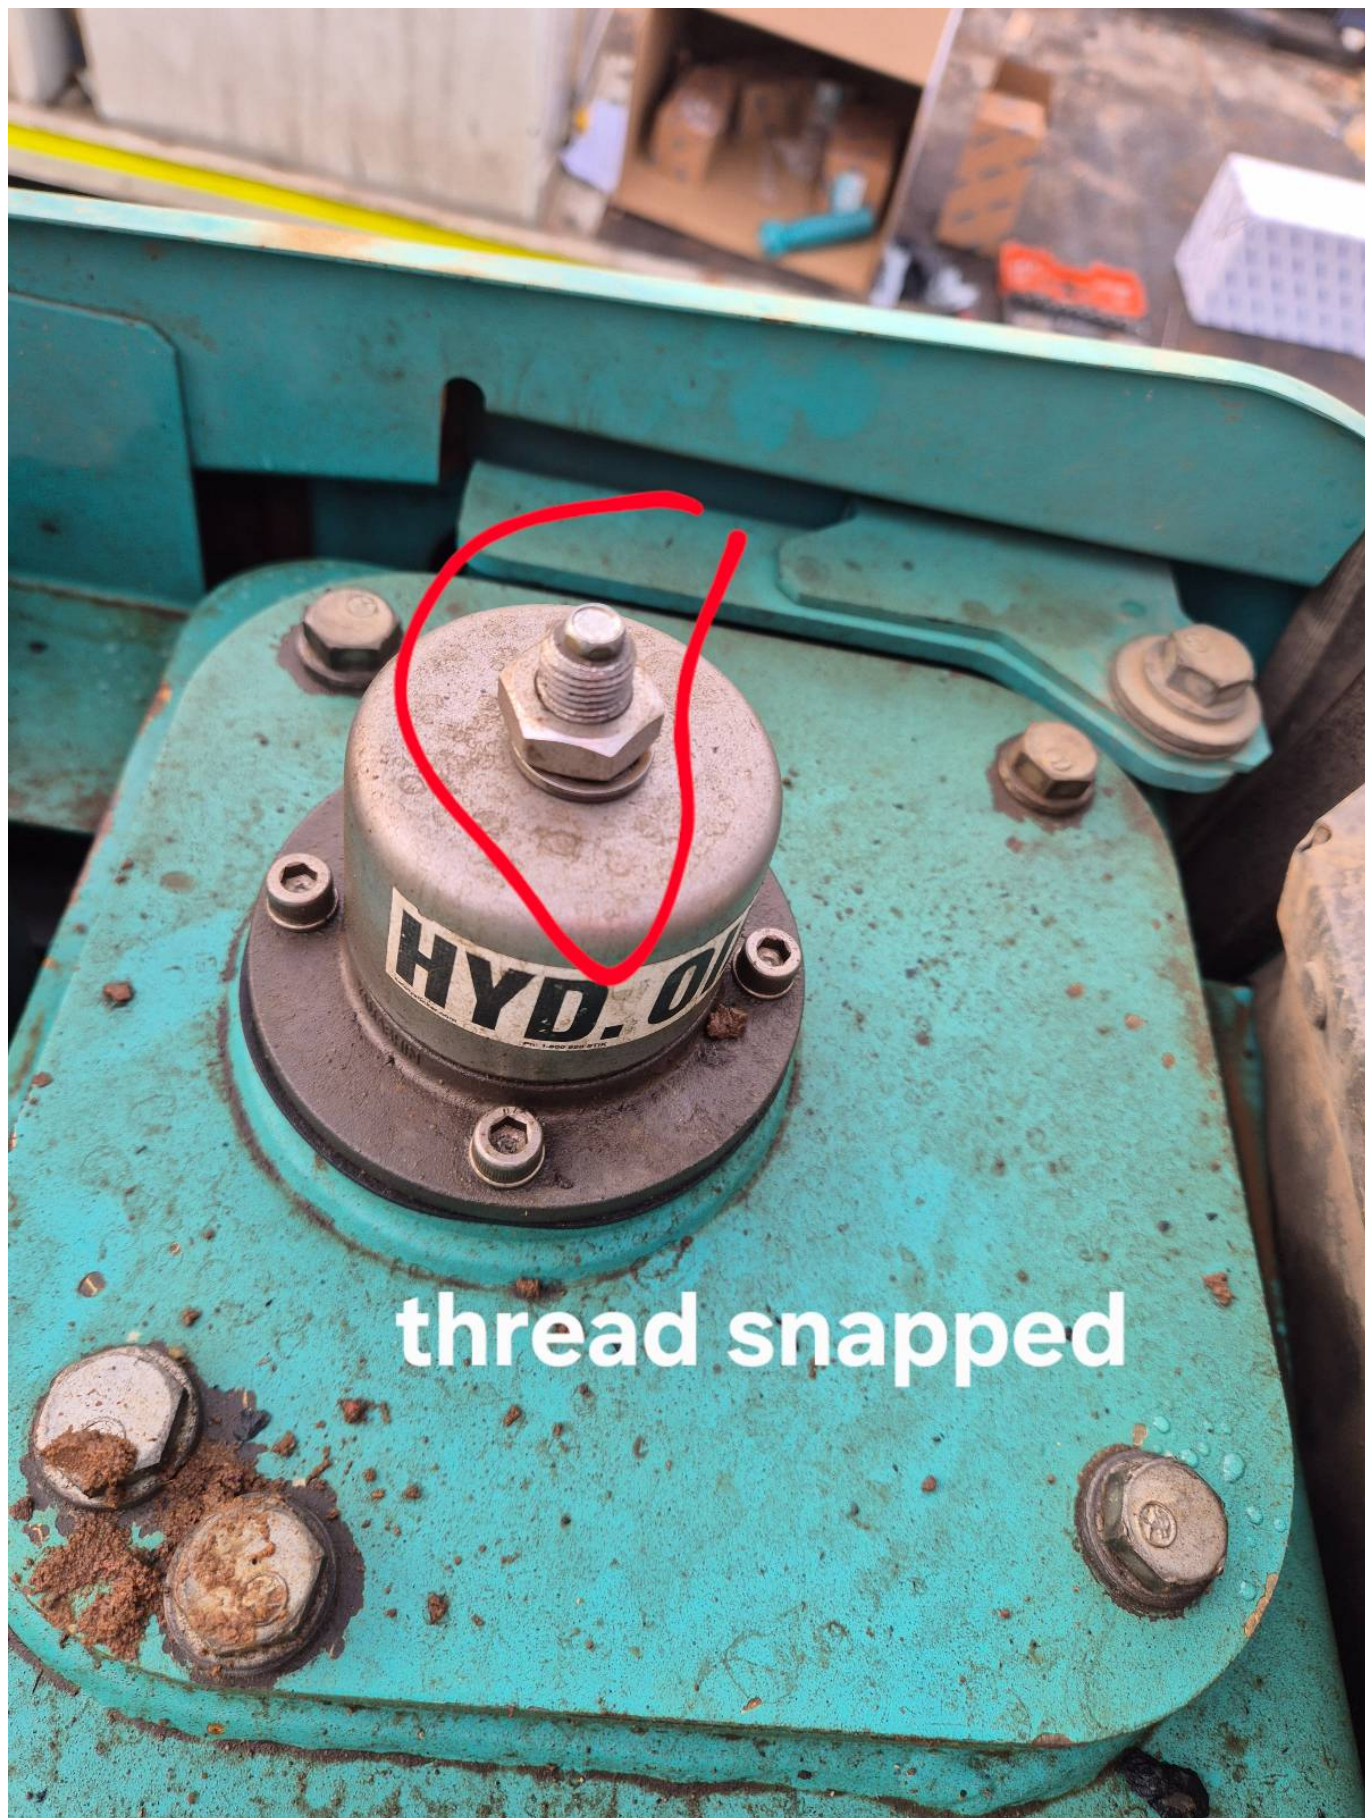
thread snapped
