## FITFLEET-EXCAVATOR-500HR-CVA

PM Checklist ● 3 ● 1 ● 97 ● 21

Model 330 Work Order SM30133

Equipment Family EXCAVATORS Completed On 5/04/2024 10:33:51 AM

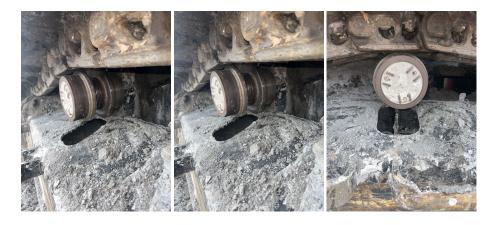
Comments: Tracks packed full of mud/dirt/ash- LEFT HAND SIDE FRONT CARRIER ROLLER BEARINGS COLLAPSED

9.3 Inspect hydraulic hoses for leaks, damage, security	PASS
9.4 Inspect hydraulic pump condition, leaks, security	PASS
9.5 Check Pilot Accumulator operation as per OEM Maintenance Procedure - Test Boom Down Functionality with engine off	PASS
PM FINAL DRIVES	
10.1 Inspect LHS final drive mount condition for leaks and security	PASS
10.2 Inspect LHS oil level and mag plug condition	PASS
10.3 Inspect RHS final drive mount condition for leaks and security	PASS
10.4 Inspect RHS oil level and mag plug condition	PASS
PM UNDERCARRIAGE	
11.1 Inspect LHS track tension	PASS
11.2 Inspect RHS track tension	PASS
11.3 Inspect tracks for loose/missing bolts	PASS
11.4 Inspect load and carrier rollers for signs of leaks	FAIL
Comments: Front carrier roller bearings LH side collapsed
